# National Transportation Safety Board

## Safety Recommendation

**Date:** April 7, 2000

**In reply refer to:** A-00-23 through -27

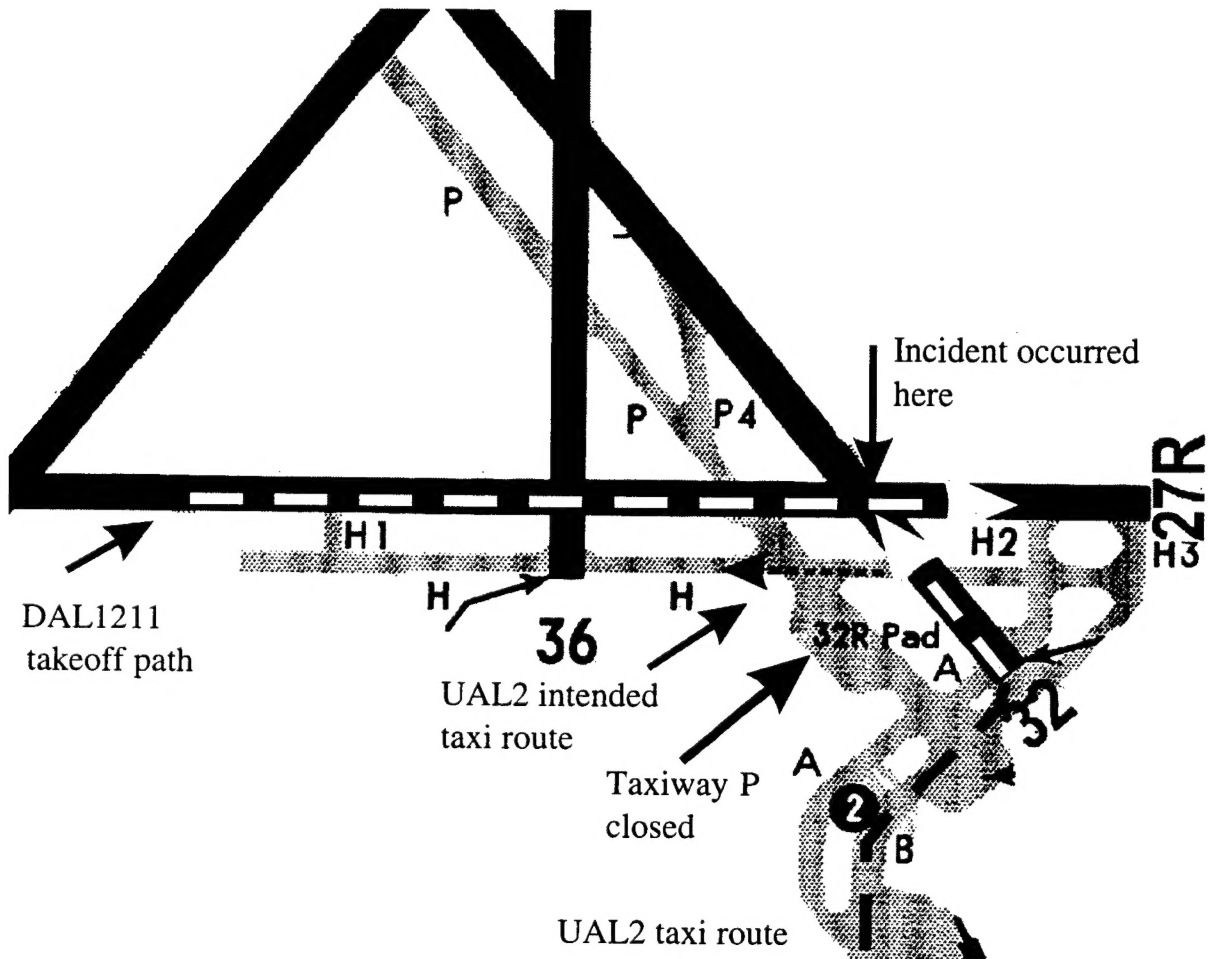
**Figure 1. ORD Airport Diagram**

Safety Board investigators found that the taxi route assigned for use between taxiways B and H at the time of the incident was not the taxi route usually assigned. Aircraft taxiing between taxiways B and H would normally follow taxiway P; however, a section of taxiway P had been closed for several weeks for reconstruction. The tower controllers elected to use runway 32R as a taxiway to bypass the closed section of taxiway P. The UAL2 crew was not familiar with that part of the route, and no signage identified taxiway H at its intersection with runway 32R.

Investigation revealed that the ORD airport certification manual approved by the Federal Aviation Administration (FAA), pursuant to 14 Code of Federal Regulations Part 139, does not require a sign at the intersection of taxiway H and runway 32R because it is close to the threshold of runway 32R and aircraft do not normally turn off there. However, when the tower controllers

elected to use runway 32R to bypass the unusable segment of taxiway P, the intersection of runway 32R and taxiway H became a frequently used taxi route for aircraft crossing the airport from west to east. The tower controllers involved in this incident reported that they were not aware that the intersection was unmarked, and airport management staff stated that they had not been informed of the tower's plan to route aircraft on runway 32R to taxiway H during the construction period. Following the incident, airport management constructed a temporary sign and installed it at the runway 32R/taxiway H intersection.

The mechanic who was taxiing UAL2 stated that he was looking for a sign identifying taxiway H. Both crewmembers stated that the area was very dark and that they did not see any signs or lights identifying taxiway H. Thus, the absence of appropriate signage and markings at the runway 32R/taxiway H intersection apparently contributed to the loss of situational awareness experienced by the UAL2 crew, causing them to miss the turn onto taxiway H. This potential problem might have been detected and addressed if ORD's ATC managers had informed airport management about its alternate taxi plan and asked that the route be checked for adequate signage and markings. Detection and correction of such problems is important because, especially in unfamiliar situations, flight and ground crews depend on proper signs and surface markings to maintain situational awareness and avoid runway incursions. Therefore, the Safety Board believes that the FAA should amend FAA Order 7210.3, "Facility Operation and Administration," to require tower ATC managers to monitor planned airport construction projects or other activities that may require significant use of nonstandard taxi routes and coordinate with airport management to ensure that such routes are inspected for adequate signage and markings.

Amend Federal Aviation Administration Order 7210.3, "Facility Operation and Administration," to require tower air traffic control managers to monitor planned airport construction projects or other activities that may require significant use of nonstandard taxi routes and coordinate with airport management to ensure that such routes are inspected for adequate signage and markings. (A-00-28)
